# CHURCH FOUNDATION RESTORATION

Large Gas Line and Soil Conditions Create Unique Repair Situation

### **ABNER CREEK BAPTIST CHURCH**

### Greer, South Carolina

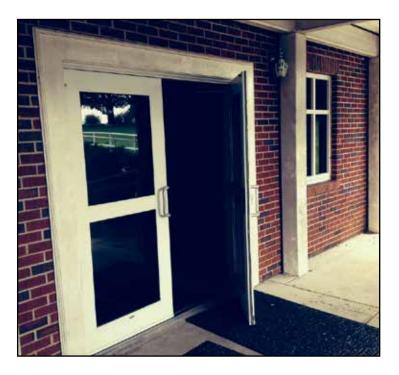
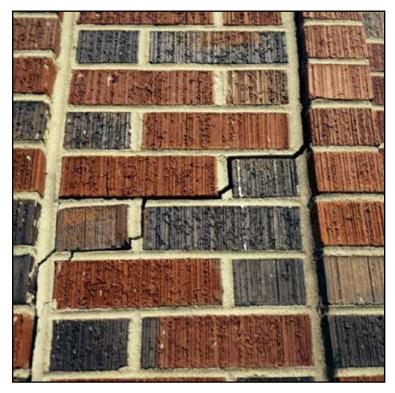
A representative of Abner Creek Baptist Church contacted Ram Jack South Carolina regarding a foundation issue. Upon inspection, it wasn't difficult to figure out why the church needed help. The electric room off the church gym was settling and separating from the main structure, causing a number of large cracks to form in the

interior and exterior walls in addition to structural damage to the building itself. The origin of the issue appeared to be normal soil settlement likely complicated by poor drainage and improper grading. The church had a two-week window for Ram Jack to perform the repair, which was complicated by the fact that a large gas line would need to be moved before a crew could install the pilings needed to repair the structure.

First, the gas line would need to be relocated in order to prevent utility damage and ensure the safety of both the repair crew and church population. Next, four exterior driven piles would be installed in the area of damage, which would subsequently be used to lift and stabilize the settling corner of the building.
