# Installation of Steel Piles Recovers Foundation

Ram Jack Closes 2 in. Gap Between Exterior Wall and Window Frame

# Ram Jack South Carolina

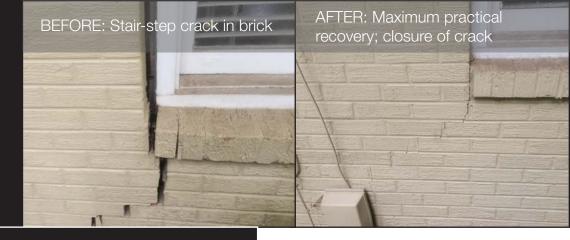
## WINDOW SEPARATION

Over the years, the soil beneath the home had settled, causing the foundation and walls resting upon it to settle also. This resulted in cracks in the mortar of the exterior brick wall growing to as much as 1 in. wide. Additionally, the wall was leaning, creating a gap of over 2 in. between the exterior wall and window frame. As a result, air was flowing freely in and out of the gap, increasing heating and cooling costs for the homeowner as well as creating an unsightly visual appearance.

Once on the job, the Ram Jack South Carolina experts modified the original plan, replacing two of the driven piles with helical piles. When finished 17 piles were installed and driven to an average depth of 15 ft., lifting the structure as much as 1 in. in some areas and stabilizing the entire compromised area. By modifying the plan, the crew was able to lift the most concerning areas as needed, almost completely closing the cracks and gaps in the brick wall. When finished, the homeowner said, "I am extremely pleased with the work and the outcome. The crew was excellent!"
