Alaskan Home Lifted 18 in. to Maximum Practical Recovery

AK201601

DRIVEN PILES SUPPORT SUNKEN ALASKAN FOUNDATION

DRIVEN-PILE STABILIZATION
ANCHORAGE, ALASKA

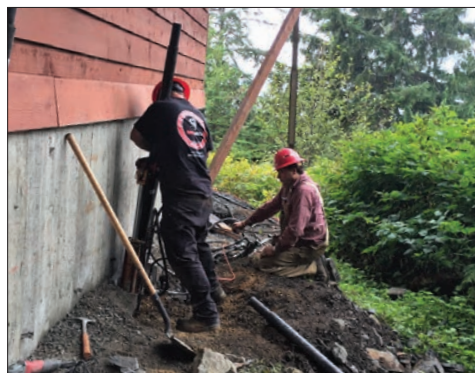
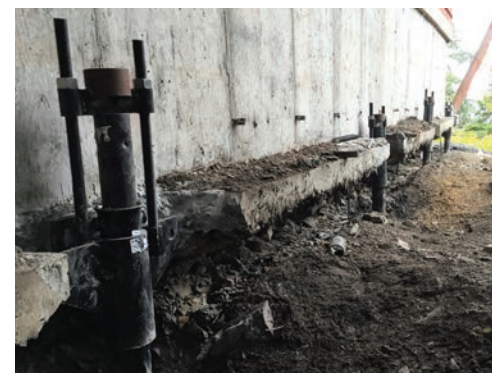
The two-story wood-frame house sits on a hillside consisting of 14 ft. of fill dirt. Although the home sits on a fairly large raised foundation with five (5) ft. stem walls, the house had sunk more than one (1) ft. in some places. The homeowner contacted Ram Jack West, based in Seattle, to find a solution to save the structure.

Ram Jack West teamed up with Ram Jack Pacific to develop the repair plan to stabilize the home by placing 13 driven piles around the perimeter of the structure.

Due to the confined work area around the home, all holes were dug by hand. The 13 driven piles were strategically placed and driven to appropriate pressures. The house was lifted 18 in. for maximum practical recovery.
